National Transportation Safety Board

Highway Accident Brief

Passenger Vehicle/School Bus Collision and Roadway Departure

Accident Number:	HWY15FH010
Accident Type:	Passenger vehicle/school bus collision and roadway departure
Location:	Eastbound Interstate 610 (I-610) overpass above Telephone Road, Houston, Harris County, Texas
Date and Time:	September 15, 2015; about 7:03 a.m.
Vehicles:	47-passenger 2009 International school bus 2004 Buick LeSabre passenger vehicle
Fatalities:	2
Injuries:	3

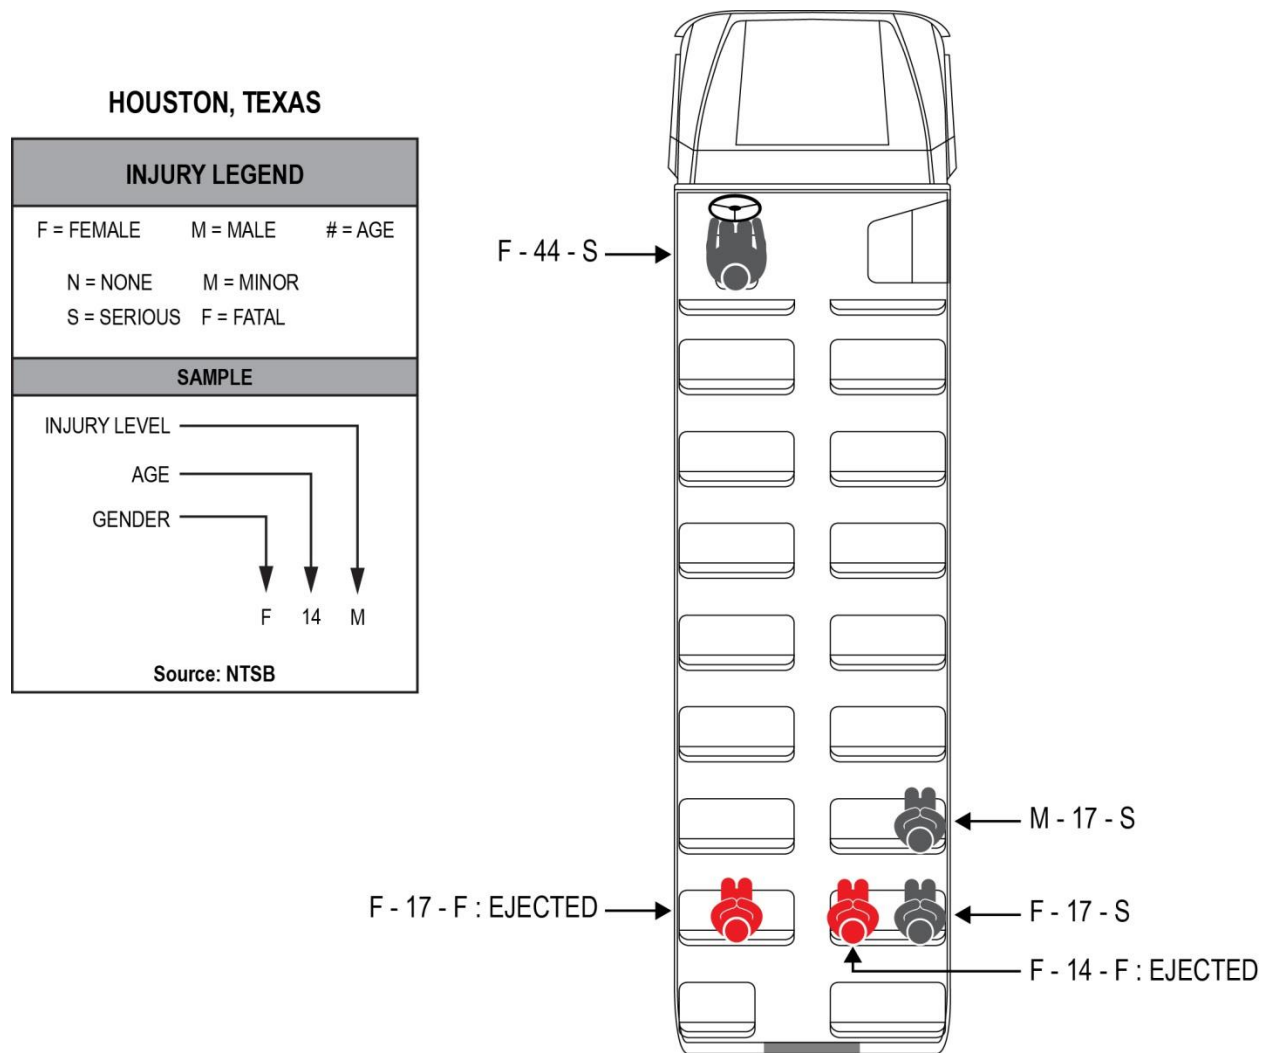
Figure 4 is a seating chart of the school bus that provides the gender, age, and injury level of the bus occupants. It also indicates the seating locations of the two student passengers who were ejected from the bus; these two students were fatally injured in the crash.

Figure 4. Seating positions, demographic information, and injury and ejection outcomes for school bus occupants. (Persons who received fatal injuries are indicated in red.)

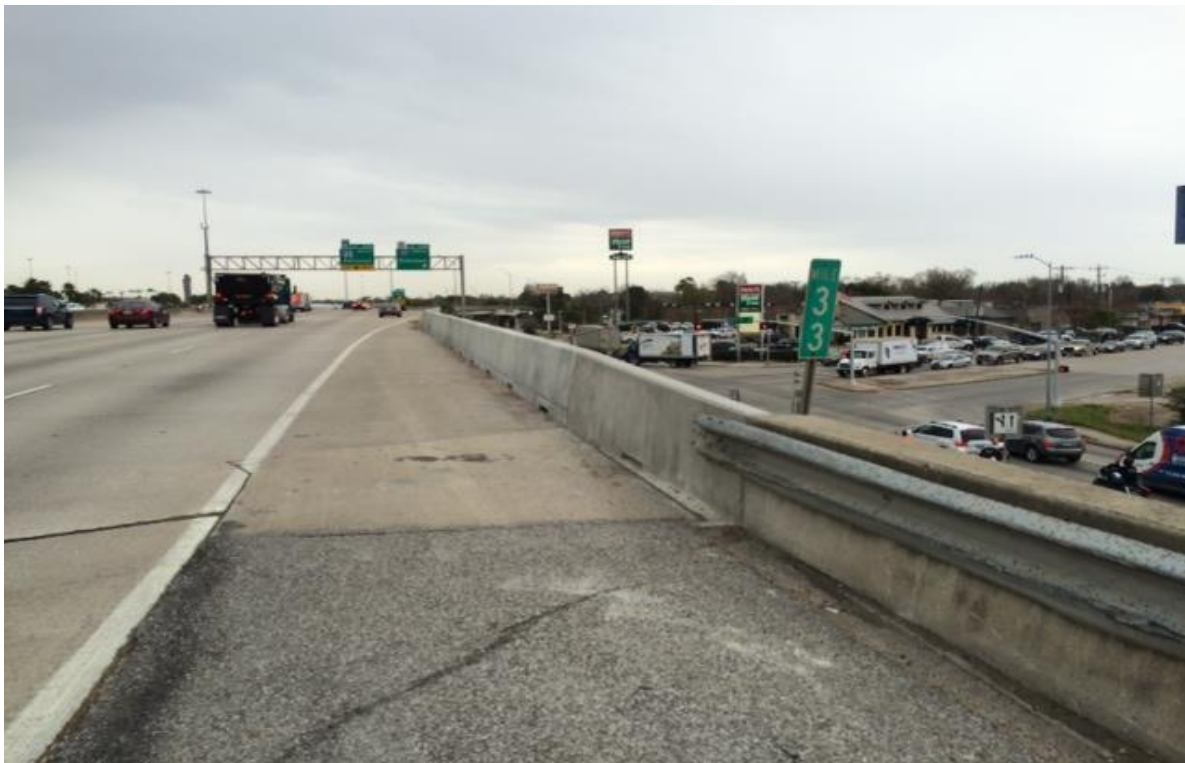
Figure 8. Looking to the southeast along the new single-sloped concrete traffic rail installed by the TxDOT Houston District after the crash. (Source: TxDOT Houston District)

TxDOT completed installation of a new rail in the crash area on December 15, 2015. Figure 8 shows the new single-sloped concrete traffic rail installed by TxDOT Houston District after the crash. The new traffic rail has a height of 3 feet, and it was installed along the entire south edge of eastbound I-610 on the overpass above Telephone Road for a distance of about 300 feet.

The new rail was a retrofit, meaning that the existing rail was removed and a new rail was installed in its place; consequently, it could not have the same type of connection to the bridge deck that such a rail would have as an initial installation. For this reason, TxDOT could only certify the new rail to TL-3. (If this same rail had been part of an entirely new bridge construction, TxDOT would have been able to certify it to TL-4.)¹³
