MARINE SAFETY ALERT

Alert 04-10

Watertight Doors – Close Them and Dog Them!

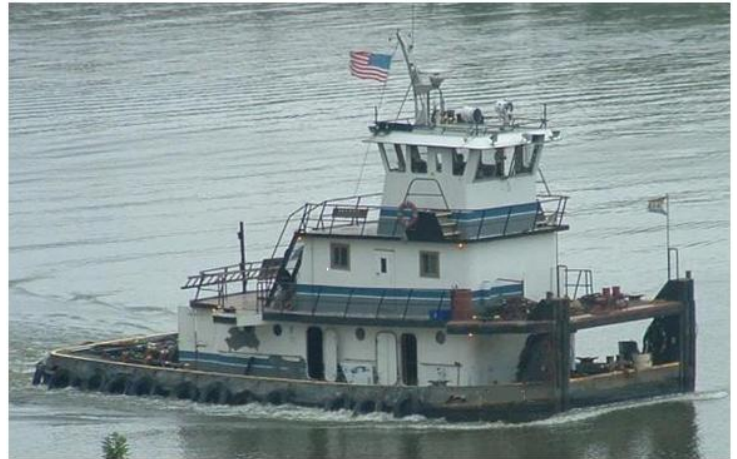
Recently a push boat operating “unfaced” (no barges attached) in the Houston Ship Channel flooded and sank while in the wake of tractor tug resulting in the death of the push boat crew and the narrow escape of two others. Although the investigation is not yet complete, it appears that the following occurred: The vessel’s watertight doors leading to its engine room had each been pinned open. The push boat had very little freeboard and was fully loaded with fuel and water. As it took the wake of the tractor tug, the vessel listed to one side and down flooded the engine room through a watertight door. As it rolled to the other side, it took on more water, eventually sinking stern first

Not Actual Vessel

CLOSE THEM and DOG THEM!
